PROJECT MANAGER  
FIREFINDER

GROUND SYSTEMS GROUP

# MAINTENANCE BULLETIN

COMMON SHELTER	FILE NO. 132-B	REVISION:
	DATE: 3/14/90	CATEGORY: INSPECTION
SUBJECT: INSPECTION OF DUAL CONTROL CARDS PART NO. 1642189-100	SYSTEMS AFFECTED: ALL

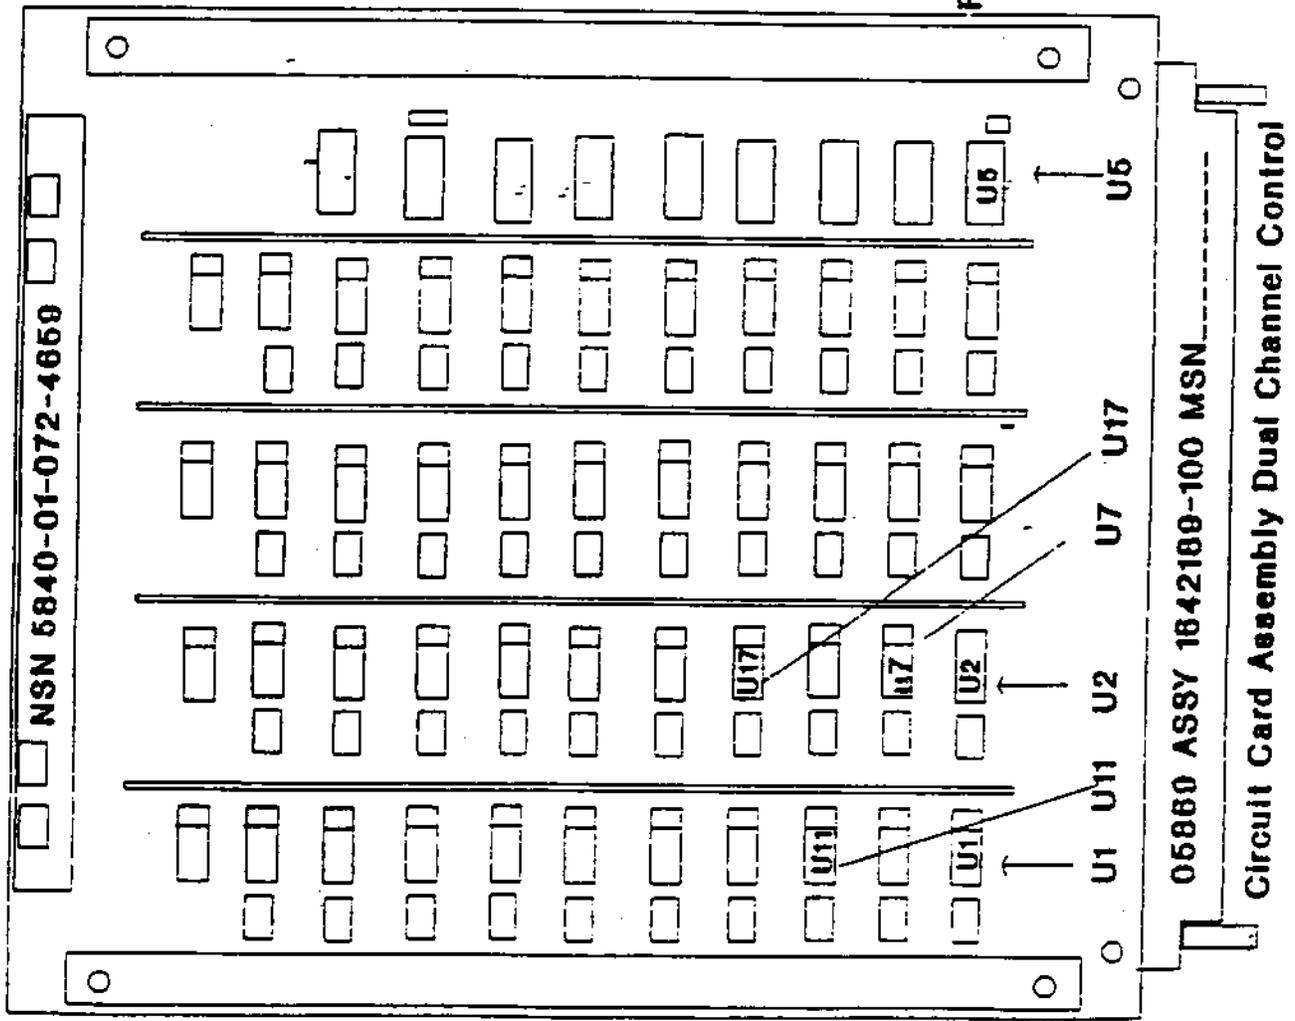
FIGURE 1

2. BACKGROUND: An unknown amount of 1642189-100 Dual Channel Control cards were built with improved 54LS257 microcircuits. This caused intermittent problems within the Radar System. Cards received by the General Support (GS) Shops and Sacramento Army Depot for repairs should contain the unimproved component for U1, U2, U5, U7, U11, and U17. (See attached figure 1 for location of components.) Following is a list of the unimproved components part numbers:

a. During the Initial Inspection for repairs of the Dual Channel Control Card (1642189-100) the technician will inspect the 1642189-100 cards to ensure that they contain the unimproved components listed in paragraph 2 above.

b. If the inspection reveals that any other than the part numbers listed above is found in the indicated locations, then the repair tag should be annotated with a remark to indicate that the card will need to be re-identify with part number 1708261-100 after repairs are completed.
